Peak Home Inspection

Property Inspection Report

Property address: **999 sample lane
 Salt Lake City, UT**

Inspection date: **Sunday, April 06, 2014**

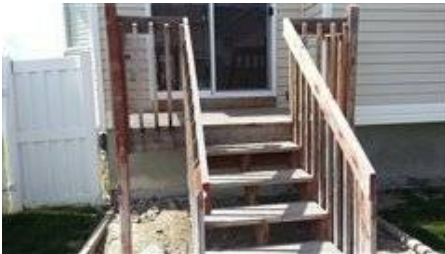
Photo 1-1

Wooden deck or porch surfaces, railings were overdue for normal maintenance. Recommend that a qualified person clean and preserve as necessary. Where decks have been coated with a finish such as opaque stains or paint, it may be too difficult to strip the finish and apply anything but paint or opaque stain. Where transparent stain or penetrating oil has been applied in the past, recommend that a penetrating oil be used. For more information, visit:

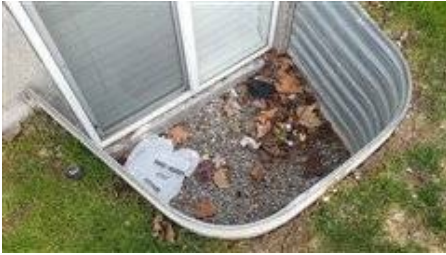
Photo 2-1

2) 🛠️ Window wells were uncovered. Recommend installing grates.

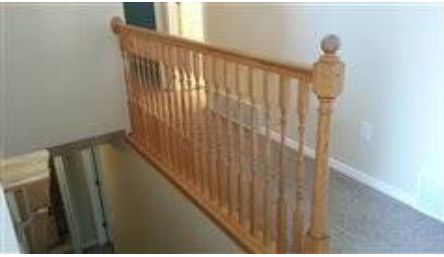
Photo 3-1

3) 🚧 Guardrails at one or more locations with drop-offs higher than 30 inches were wobbly, and pose a fall hazard. Recommend that a qualified person repair guardrails as necessary.

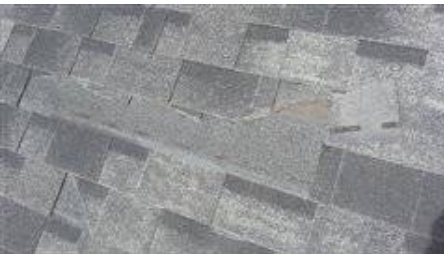
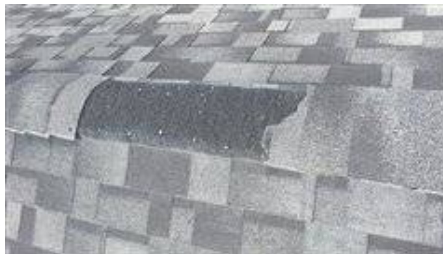
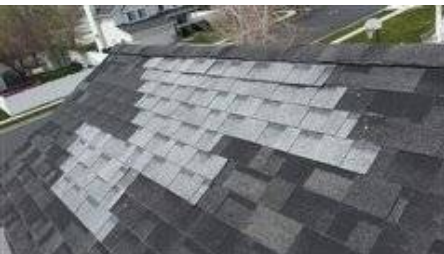
Some composition shingles were missing, damaged. Leaks can occur as a result. This is a conducive condition for wood-destroying organisms. Recommend that a qualified contractor repair as necessary. For example, by replacing shingles.

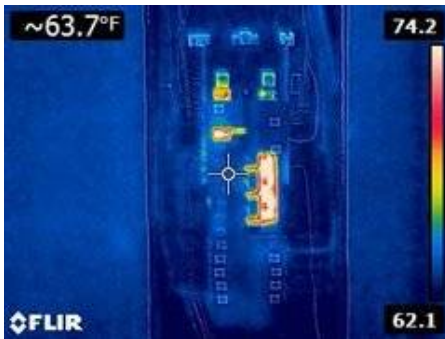
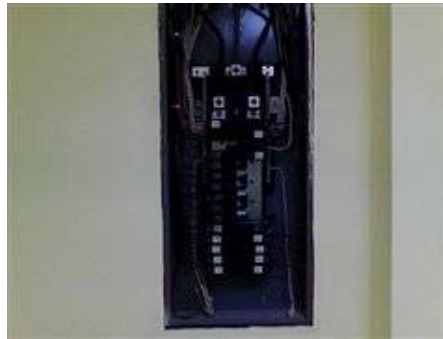
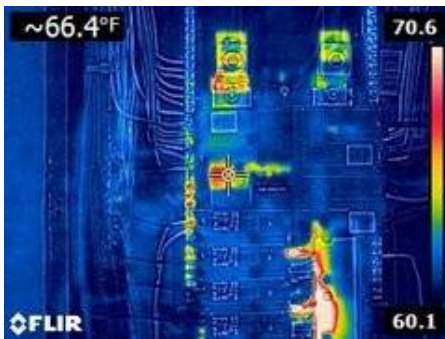
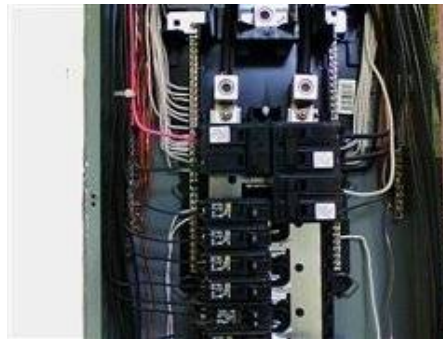
6) Breaker box with thermal. no hot spots found on breakers.

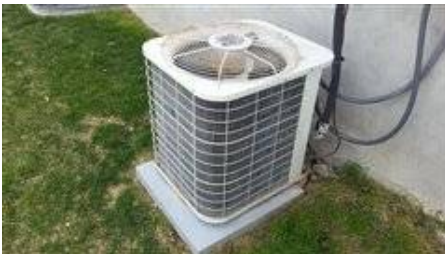
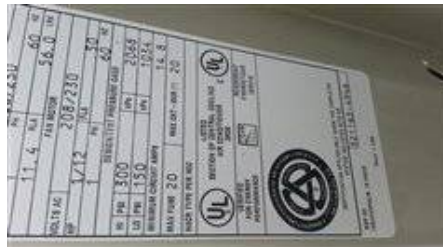
The estimated useful life for most heat pumps and air conditioning condensing units is 10-15 years. This unit appeared to be near this age and/or its useful lifespan and may need replacing or significant repairs at any time. Recommend budgeting for a replacement in the near future.

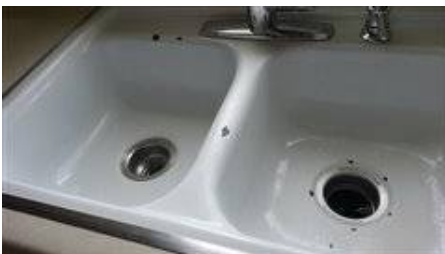
Photo 12-1

The sink had minor wear, blemishes or deterioration.

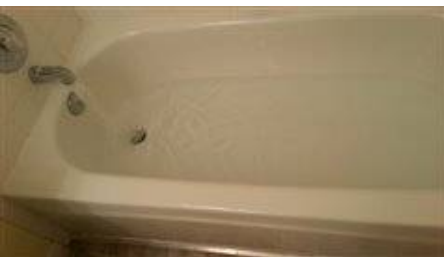
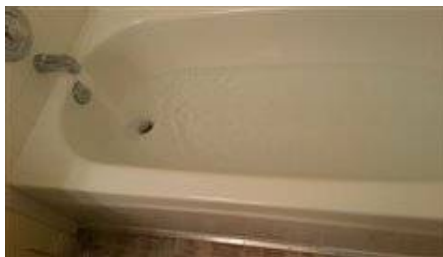
The Bathtub at location(s) #A drained slowly. Recommend clearing drain and/or that a qualified plumber repair if necessary.
